Beneteau 211 Keel Servicing  
alansm04@yahoo.co.uk

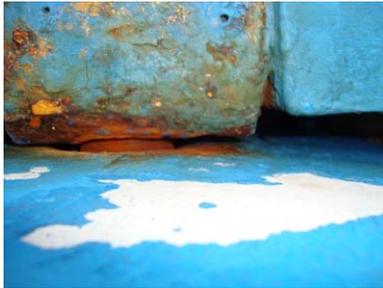
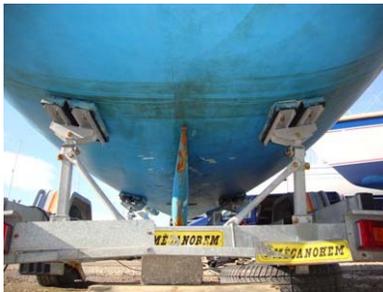
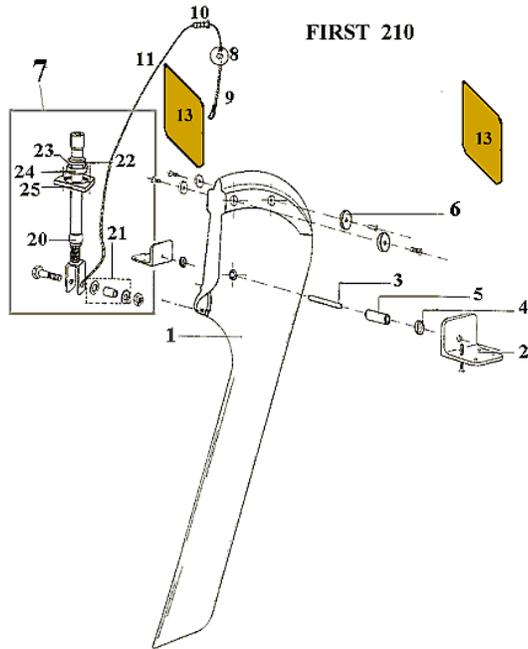
My First 211 is 12 years old and used in salt water. The keel has been progressively noisy, making clanking sounds in rough waves. I noticed that it was leaning to one side by several degrees when placed on the trailer this year so I decided to replace the keel pivot, nylon bushes and angle brackets.

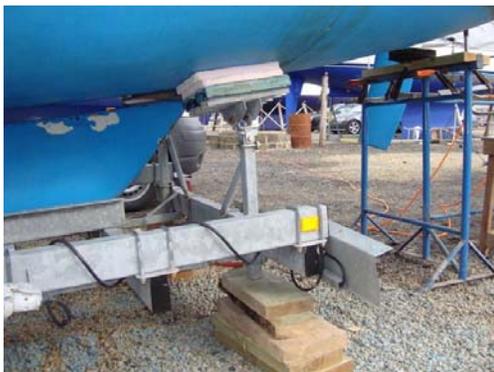
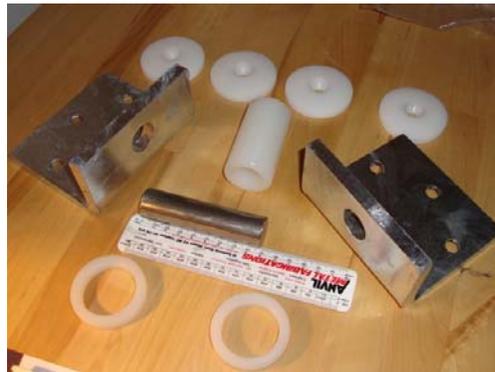
I decided to do the work from my trailer by raising the boat 50mm on Styrofoam pads which gives just enough clearance. The hardest part of this job is breaking the seal between the brackets and hull. It eventually released by levering the keel up and down with a crowbar and using the full weight of the keel.

The job was reasonably straight forward but the new bracket holes didn't align correctly which was a bit of a pest to say the least! CHECK THE HOLE ALIGNMENT BEFORE APPLYING ANY MASTIC! The brackets were ordered from Beneteau and £50 a piece. They are 10mm galvanised mild steel (not Stainless). If I did this again I'd have the new brackets fabricated in stainless.

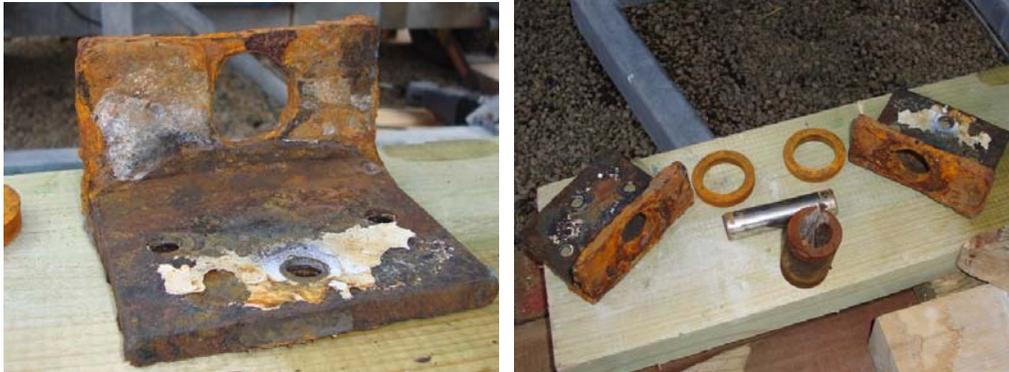
When I removed the old brackets I was alarmed to see how corroded and oval the holes had become. Another season could have resulted in the keel falling out!

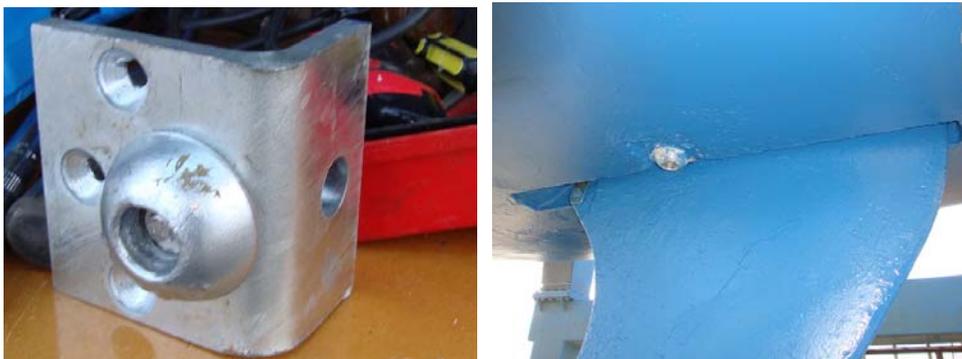
The nylon parts and the original stainless steel pivot pin were all in perfect condition which makes me think that all the pivoting has been between the stainless steel pin and the mild steel brackets. I had to cut the nylon bearing through the keel as it wouldn't budge. The pivot hole through the keel was sound with no rust. I also decided to fit a zinc anode to help protect against future rust.

I painted the pivot holes on the angle brackets before inserting the new pin and greased the main nylon bearing to ensure that the pivoting would be in the correct place in future. I used plenty `Sikaflex marine sealant 291' to ensure a good seal around the bolts.

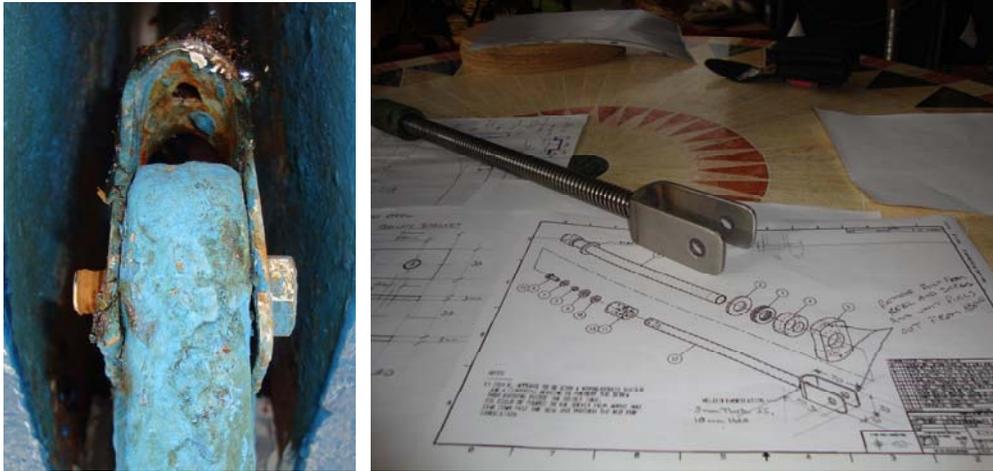
I also had to repair the keel lifting mechanism as the fork was damaged and the bolt badly corroded. This is an M12 bolt with Nyloc nut (17mm spanner)

This job **can't be done on the trailer** but is easily accessible when the boat was lifted for launching. My local blacksmith fabricated and welded on a new stronger SS fork for £30.
